**SUBJECT: SSC 50N - STEERING RELAY ROD REPLACEMENT
CERTAIN 1989 – 1995 TRUCK 4WD, 1990 – 1995 4RUNNER 2WD AND 4WD, AND 1993 –
1998 T100 4WD VEHICLES (BOTH WITH AND WITHOUT POWER STEERING)**

**STEERING RELAY ROD REPLACEMENT
FOR THE FOLLOWING VEHICLES**

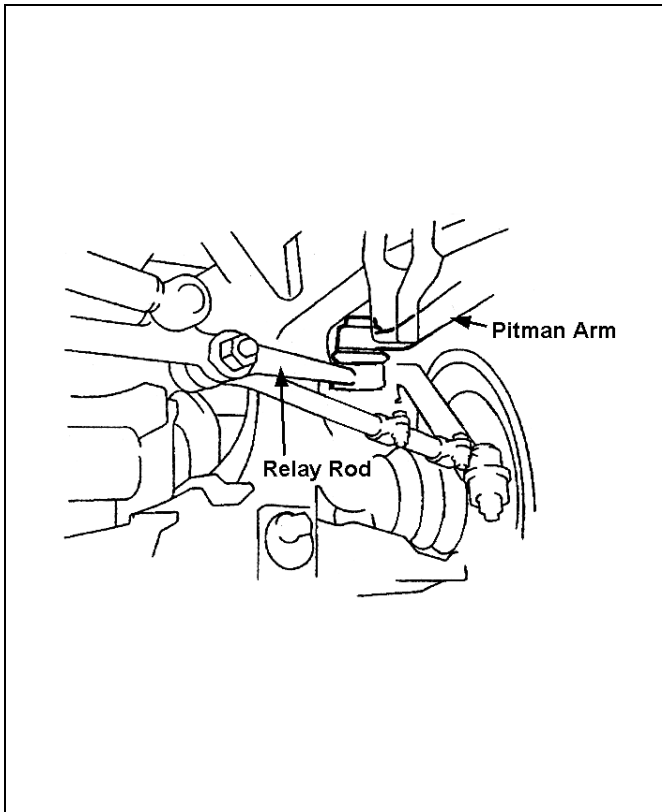
4. RECONNECT THE PITMAN ARM TO THE NEW RELAY ROD

- (a) Reconnect the pitman arm to the new relay rod.
- (b) Install the new nut included in the kit and torque to specification.

To prevent the over torque condition we have revised the torque specification.
